03V-120

Subject: **PART 573— DEFECT AND NONCOMPLIANCE REPORTS**
Emergency Window Handle pull force, installed in Orion buses

Number: SIL-03/02

Subject: Emergency Exit Window Maintenance for Excel™ Type Egress Window Assemblies.

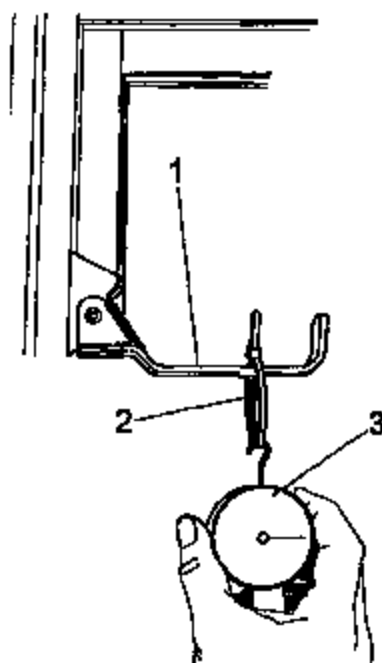
Figure 1-4 Checking Egress Handle Tension

3. Check the reading: An acceptable reading is 20 lbs. (89 newtons) or less.
 4. If reading exceeds 20 lbs. (89 newtons), repeat steps 1 - 7 and 1 - 4 above.
-

1. Attach tension gauge (3) to the egress handle (1) with a wire tie (2). See Figure 1-3.
 2. Slowly pull the gauge (3) until egress handle (1) releases. See Figure 1-4.
-

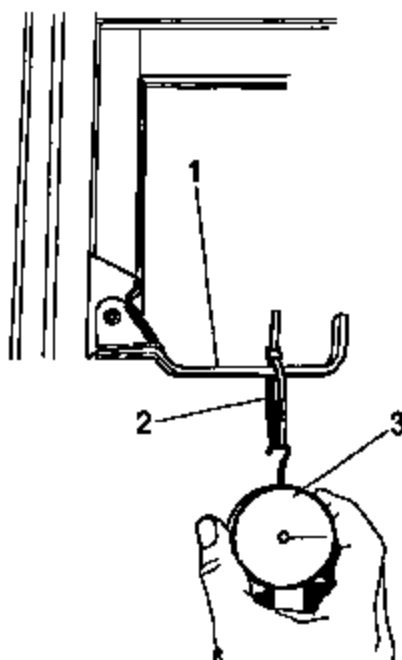
Figure 1-2 Checking Egress Handle Tension

3. Check reading: An acceptable reading is 20 lbs. (90 newtons) or less.

1. Attach force gauge (3) to the egress handle with a wire tie (2). See Figure 1-1.
2. Slowly pull the gauge (3) until egress handle (1) releases. See Figure 1-2.
